Overcoming Water Inflow Issues at Sir Adam Beck 1 Generating Station

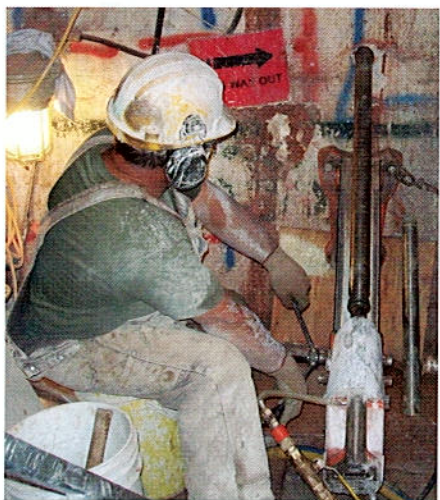
Over time, water inflows began to seep through the brick lining at various locations, leading to corrosion of the support steel for the elevator compartment. Crumbling shale blocked several of the vertical chimney drains and further compounded water inflow problems.

When starting this project, one of the difficulties to be overcome was that the site conditions were hidden behind the brick lining, so it was not possible to identify and target specific water inflow locations. OPG personnel who were familiar with the rock formations through which the elevator shaft had been constructed selected the Decew formation as a likely source of water inflow, so initial work was targeted in this area.

Grouting work consisted of several stages that included shallow chemical grouting to a depth of 0.6 m, deeper chemical grouting to a depth of 1.2 m, followed by cement grouting with holes drilled to a depth of 4 m. The initial chemical grouting work resulted in an immediate and significant reduction in water inflow entering the shaft although water was subsequently encountered

By the time that all grouting operations had been completed, residual water inflows entering the elevator shaft from all areas had been reduced to less than 30 cubic metres each day, and nuisance water inflow problems from the targeted area had been eliminated.
