## **GROUND IMPROVEMENT BY CEMENT GROUTING COMBINES WITH PIPE PILES IN BRIDGE CONSTRUCTION**

A bridge reconstruction project involved driving pipe piles for the new foundations. Disturbances within soil layers at depth caused sinkholes to open up within the construction site.

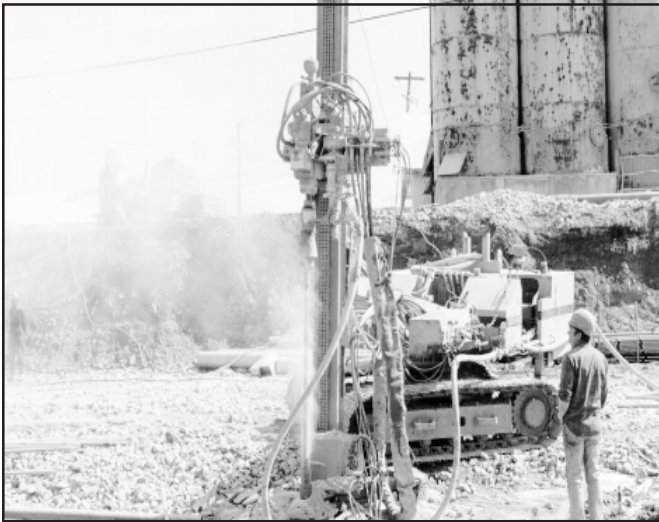
**FIGURE 2 - DK 100 Drill Rig in Operation**

Figure 2 shows the DK 100 drill rig drilling into limestone after the casing has been installed through overburden.

A Davey-Kent DK 100 crawler-mounted drill rig was used for drilling probe holes for site evaluation and grouting purposes. This drill rig enabled the concurrent driving of a drill string and external casing through overburden and unconsolidated ground. After the casing had been seated into competent rock, the drill string was used to complete drilling operations in a conventional manner.

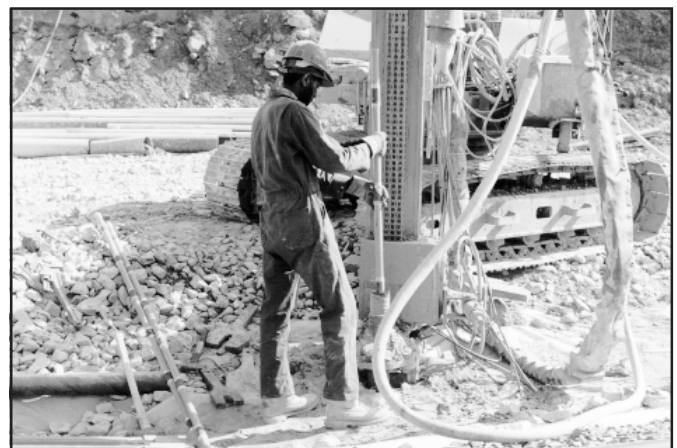
**FIGURE 3 - Plastic Sleeve Pipes Being Installed**

Figure 3 shows plastic sleeve pipes being installed through the drill casing following completion of drilling operations.

Following completion of drilling operations, plastic 1-1/8" diameter sleeve pipes were installed to the full depth before withdrawing the casing and moving to the next adjacent hole. Sleeve pipes were supplied in 10 foot lengths and featured trapezoidal thread connections with an external coupling for fast assembly. Installation time required only a few minutes per hole, so the delay to drilling operations was minimal.

The sleeve pipes were perforated every 20 inches along the pipe length and the perforations were enclosed by an external rubber sleeve. The rubber sleeve served as a one-way valve to allow cement grout to be pumped from the sleeve pipe without the sleeve pipe becoming clogged with grout, dirt or debris.

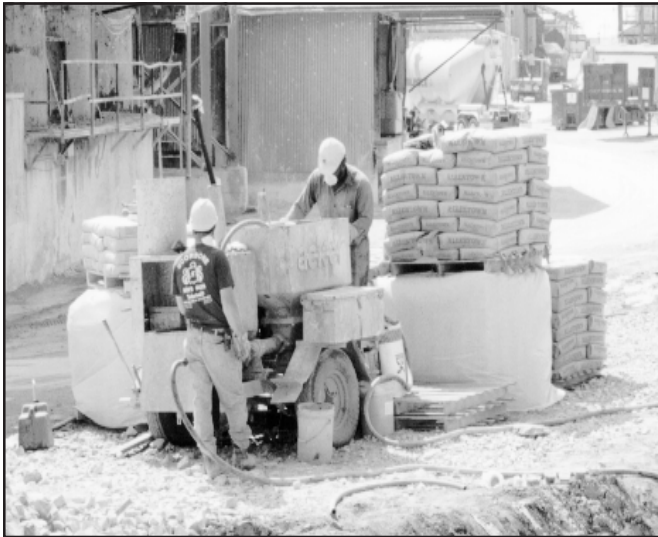
**FIGURE 4 - Colloidal Grout Unit in Operation**

Figure 4 shows the Acker 4 ft<sup>3</sup> diesel-hydraulic, colloidal mixing unit in operation. This unit was self-contained with a colloidal mixer, agitator and moyno grout pump. Each of the grout ingredients were pre-measured in suitable containers to accommodate a one-sack batch of grout. Grout output was in the range of 1 - 2 ft<sup>3</sup> per minute, which was sufficient to balance the rate of drilling progress. Grout was discharged from a central location through 1 inch grout hoses to the required locations on the job site.

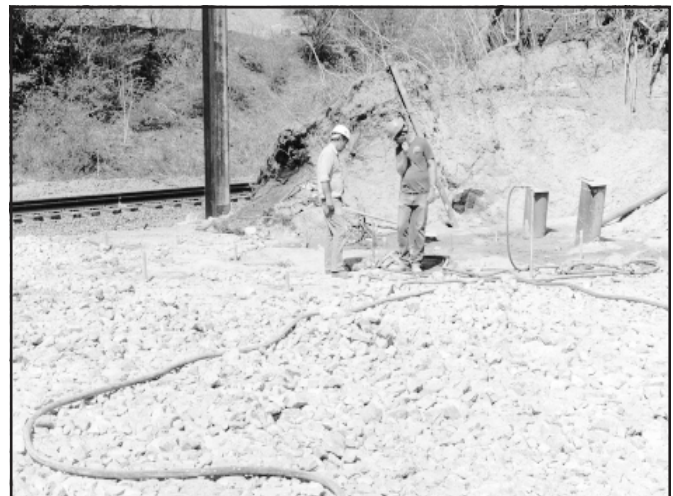
**FIGURE 5 - Typical Sleeve Pipe grouting Operation**

Typical grouting operations are shown in figure 5. The initial pipe piles can be seen in the background with an array of plastic sleeve pipes installed in the foreground.

The grouting equipment consisted of a slotted packer pipe with pot packer rings at either end to isolate the slotted pipe within the plastic sleeve pipe. The length of the slotted packer pipe was varied according to site conditions and could cover two or three sets of sleeve pipe perforations at one time in order to maximize grouting productivity.

The slotted packer pipe was raised and lowered by steel pipes and connected to the grout delivery hose from the grout plant. Subsequently, a special high-pressure hose assembly was used to replace the steel pipes to further increase grouting productivity.
